Bearing failures and their causes

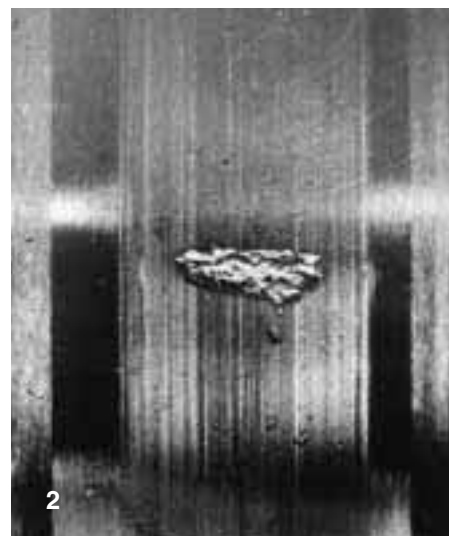
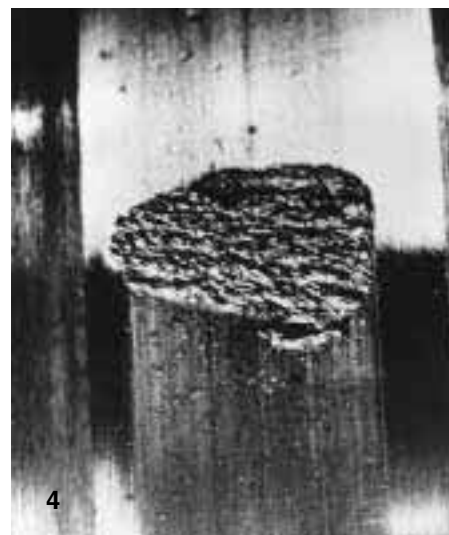
magnitude of the load. Fatigue is the result of shear stresses cyclically appearing immediately below the load carrying surface. After a time these stresses cause cracks which gradually extend up to the surface. As the rolling elements pass over the cracks fragments of material break away and this is known as flaking or spalling. The flaking progressively increases in extent (figs 1 to 4) and eventually makes the bearing unserviceable.

Figs 1–4 Progressive stages of flaking

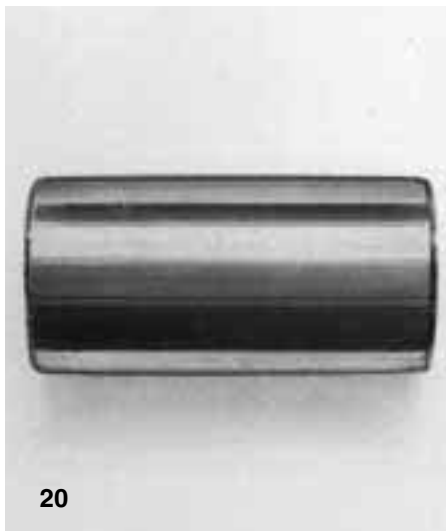
Worn, frequently mirror-like, surfaces; at a later stage blue to brown discolouration.

Fig 20 Cylindrical roller with mirror-like surface on account of lubricant starvation

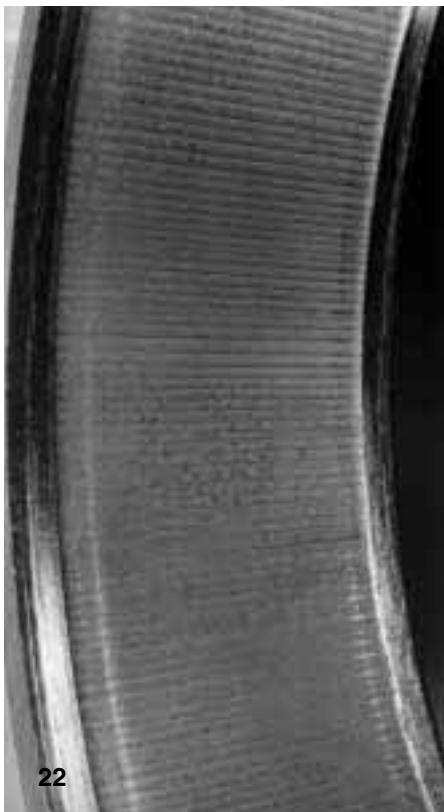
Fig 22 Outer ring of taper roller bearing damaged by vibration during operation

Secure the bearing during transport by radial preloading.
Provide a vibration-damping base.
Where possible, use ball bearings instead of roller bearings.
Employ oil bath lubrication, where possible.

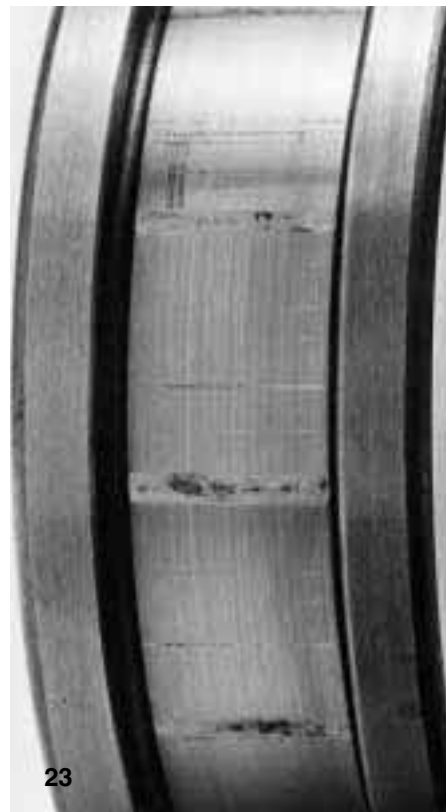
Fig 23 Vibration damage to the ring of cylinder roller bearing. The damage has arisen while the bearing was not running. It is evident, from the fainter fluting discernible between the pronounced depressions with corrosion at the bottom, that the ring has changed position for short periods

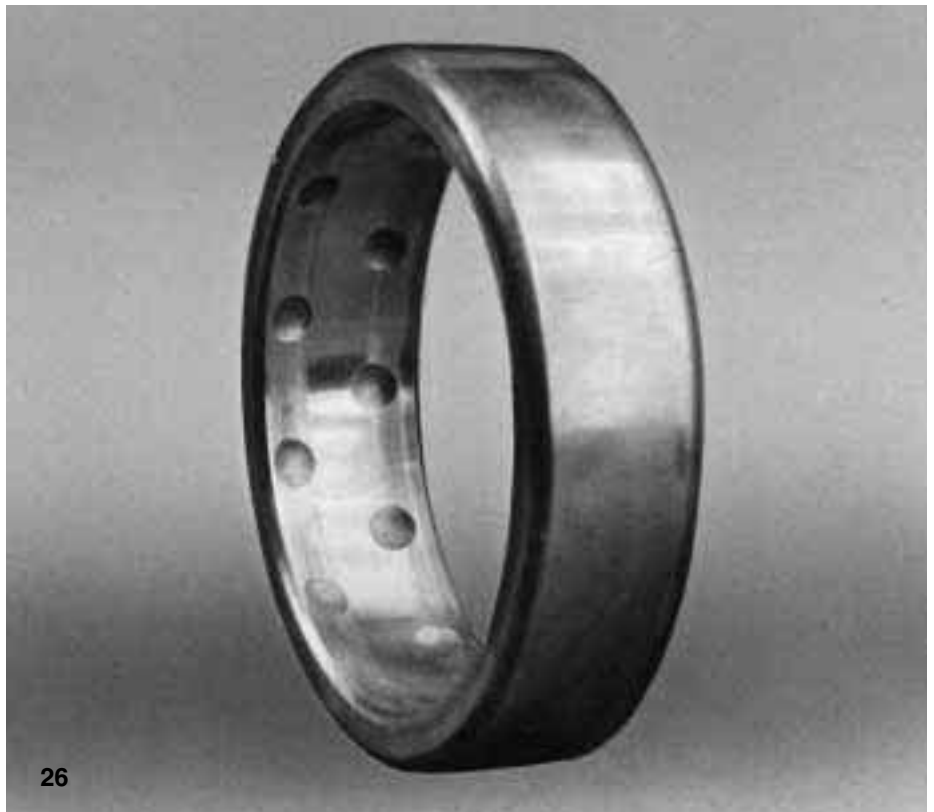
Fig 26 Outer ring of a self-aligning ball bearing damaged by vibration. The bearing has not rotated at all

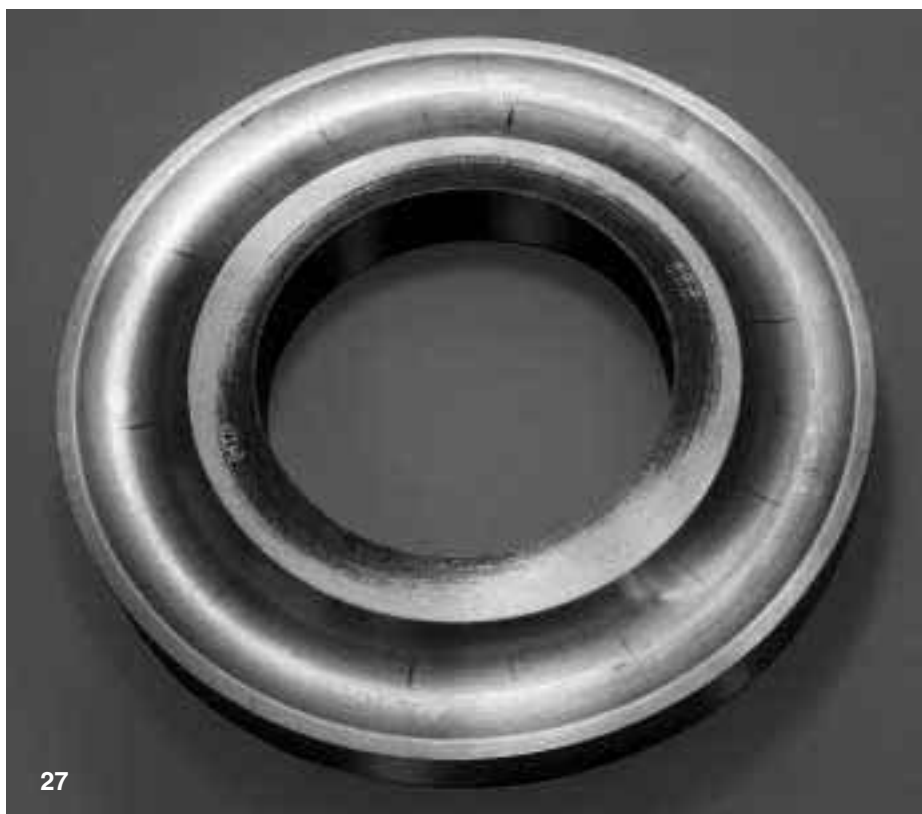
Fig 27 Washer of a thrust ball bearing subjected to overloading while not running. The indentations are narrow and radially aligned, not sphered as in radial ball bearings

Avoid overloading or use bearings with higher basic static load ratings.

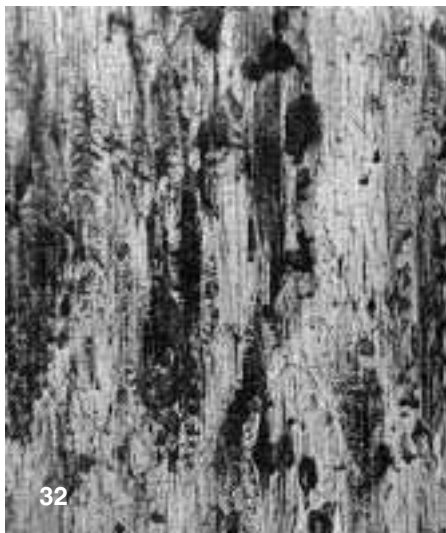
Fig 32 Smearing on the surface of a roller from a spherical roller bearing – 100 × magnification

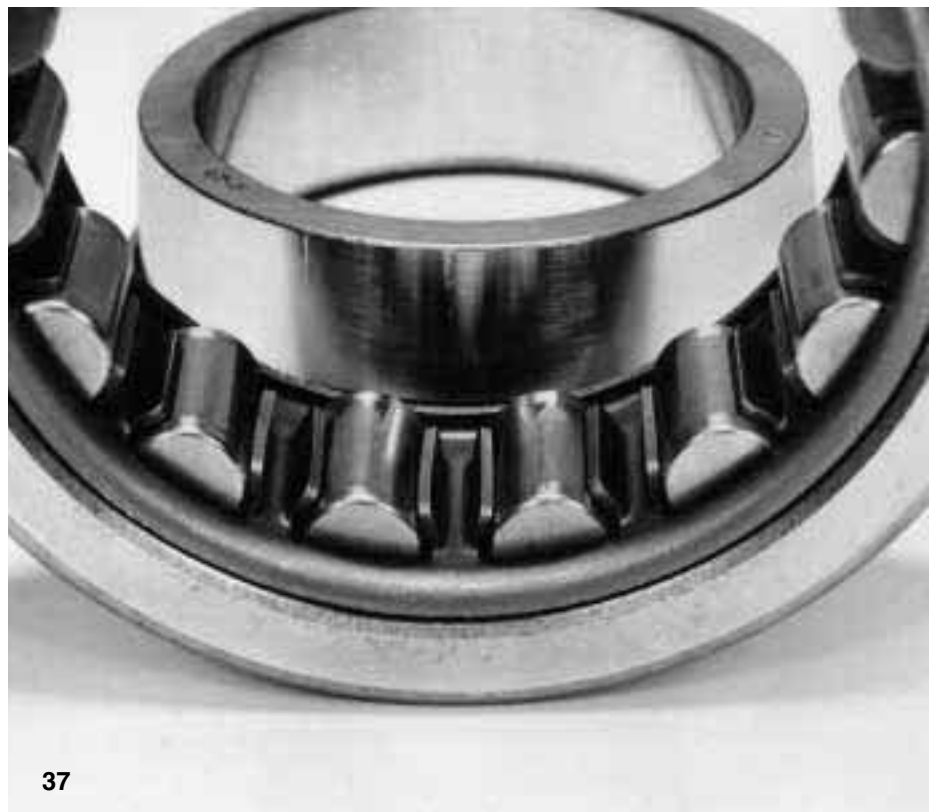
Fig 37 A cylindrical roller bearing with smear streaks in the inner ring raceway and on the rollers. The smearing has been caused by the roller assembly being entered askew without being rotated

Rotate the bearing when it is being adjusted. Apply the mounting force against the ring with the tightest fit; never allow the force to pass through the rolling elements.

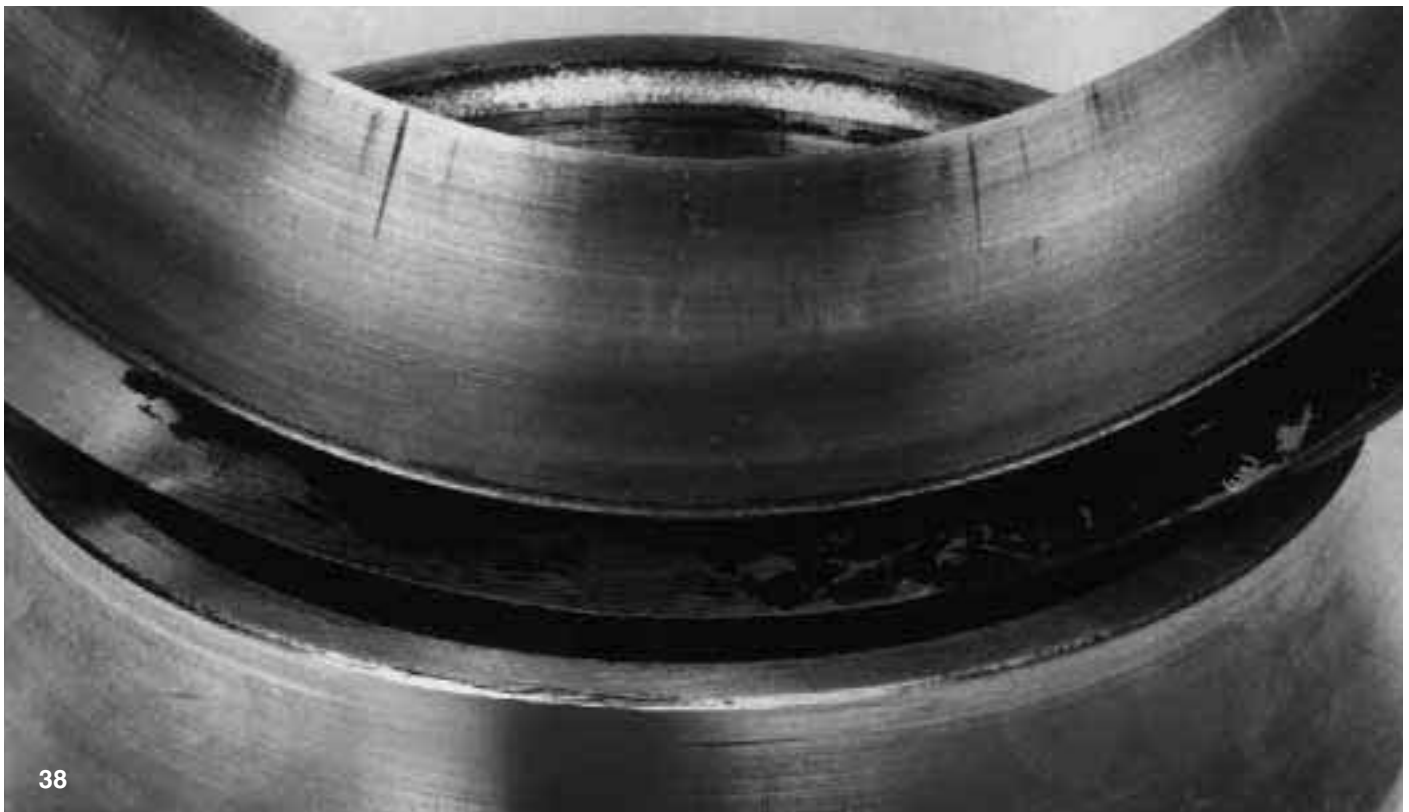
Fig 38 Outer ring raceway of a spherical roller bearing with smear streaks caused by a blow against the inner ring

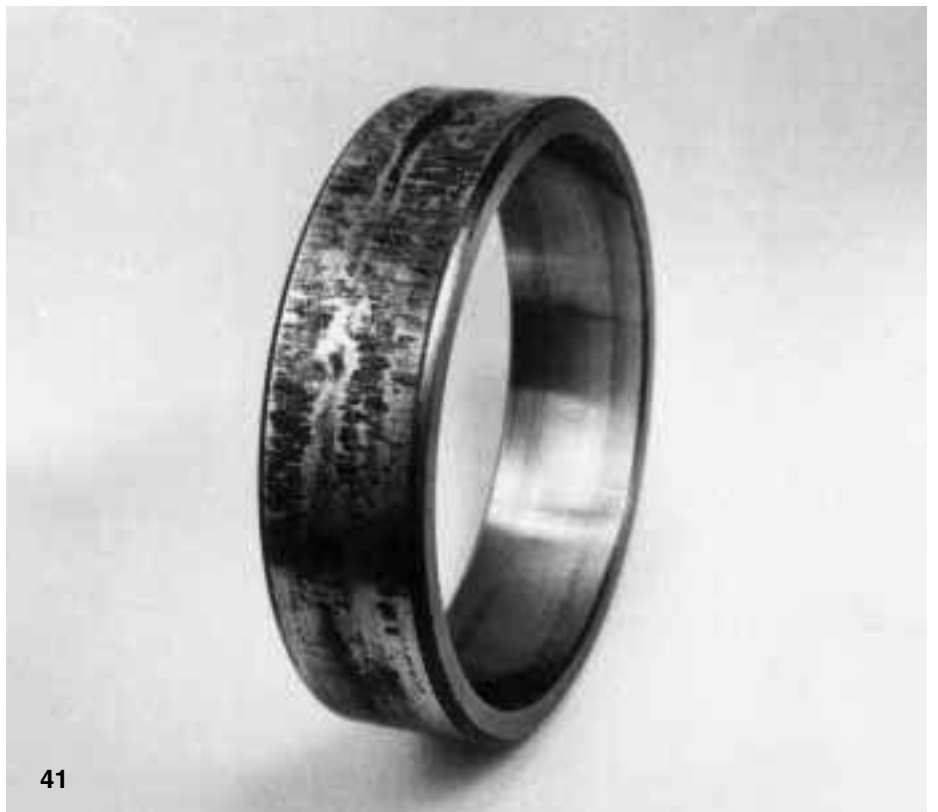
Fig 40 Smeared face of a cylindrical roller bearing inner ring

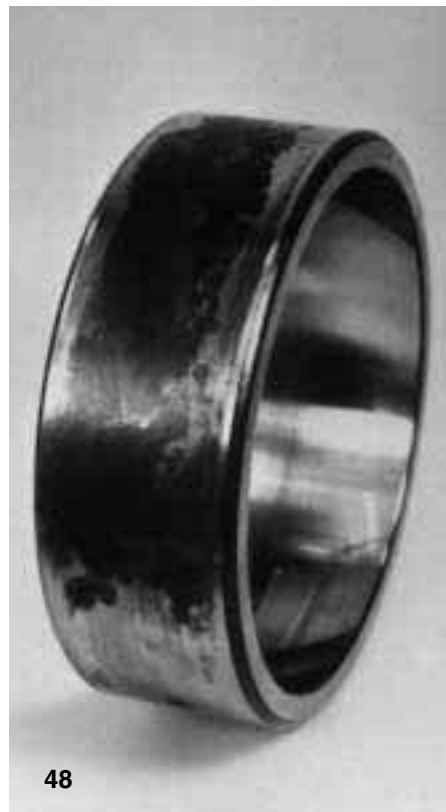
Fig 48 Fretting corrosion on the outer ring of a spherical roller bearing

Adjust seatings.

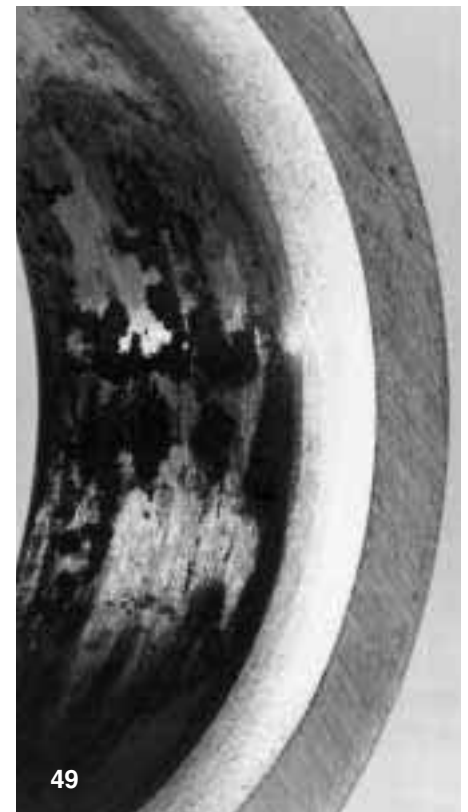
Fig 49 Extensive fretting corrosion in the bore of a self-aligning ball bearing

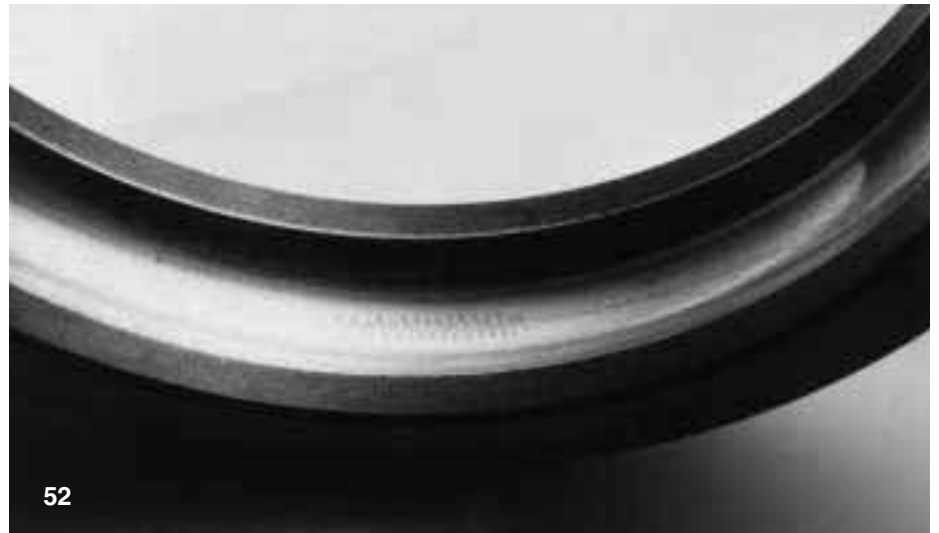
Fig 52 Deep groove ball bearing with electric current damage in zigzag pattern. It is assumed that burns of this configuration arise when the momentary passage of high amperage current is accompanied by axial vibration

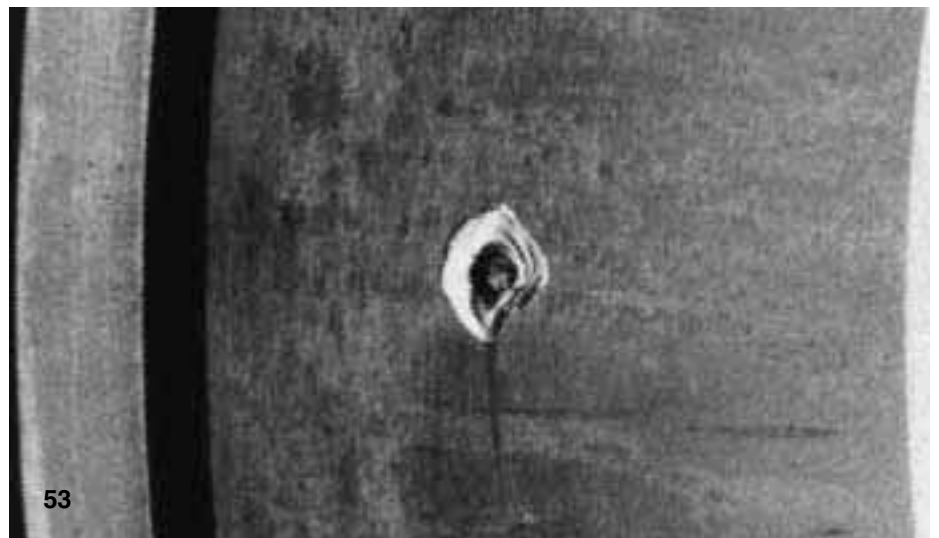
Fig 53 A railway axlebox bearing damaged by the passage of high amperage current while the bearing was not running

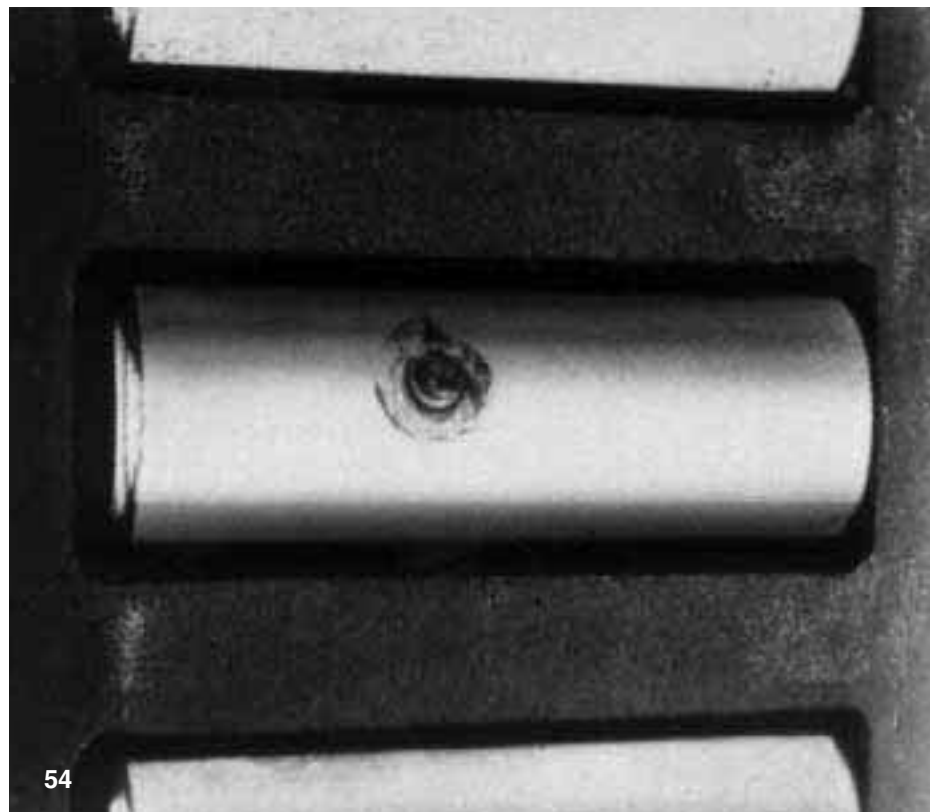
Fig 54 Roller of a railway axlebox bearing damaged by electric current (same bearing as in fig 53)

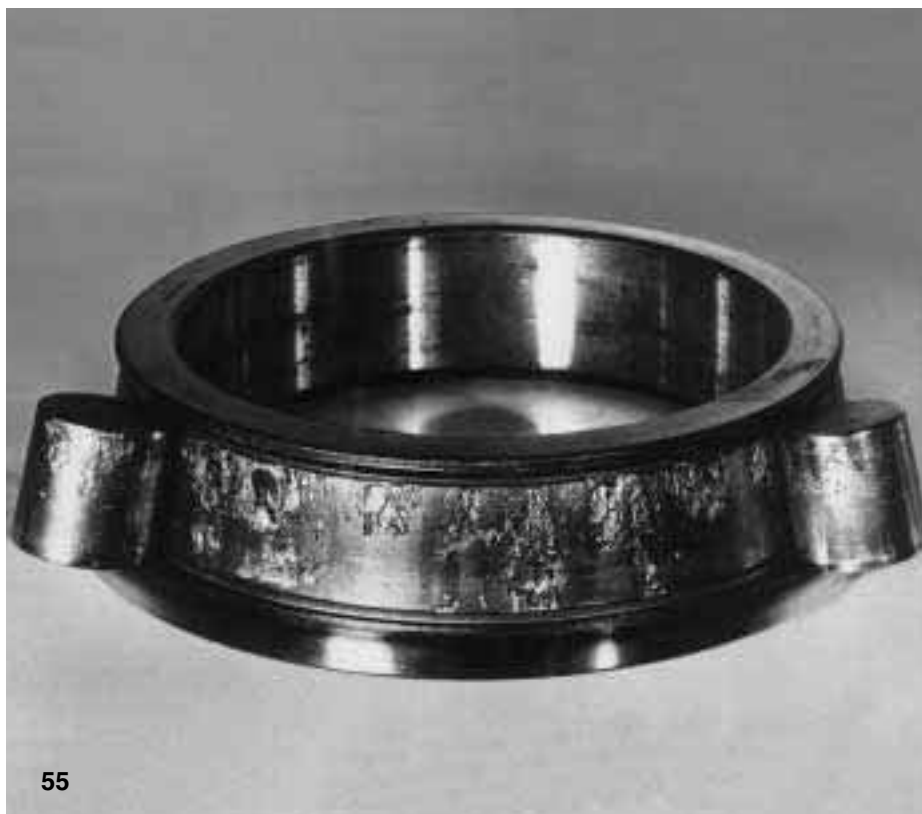
Fig 55 Flaked cone and rollers of taper roller bearing. Heavy loading and inadequate lubrication are the causes of this damage

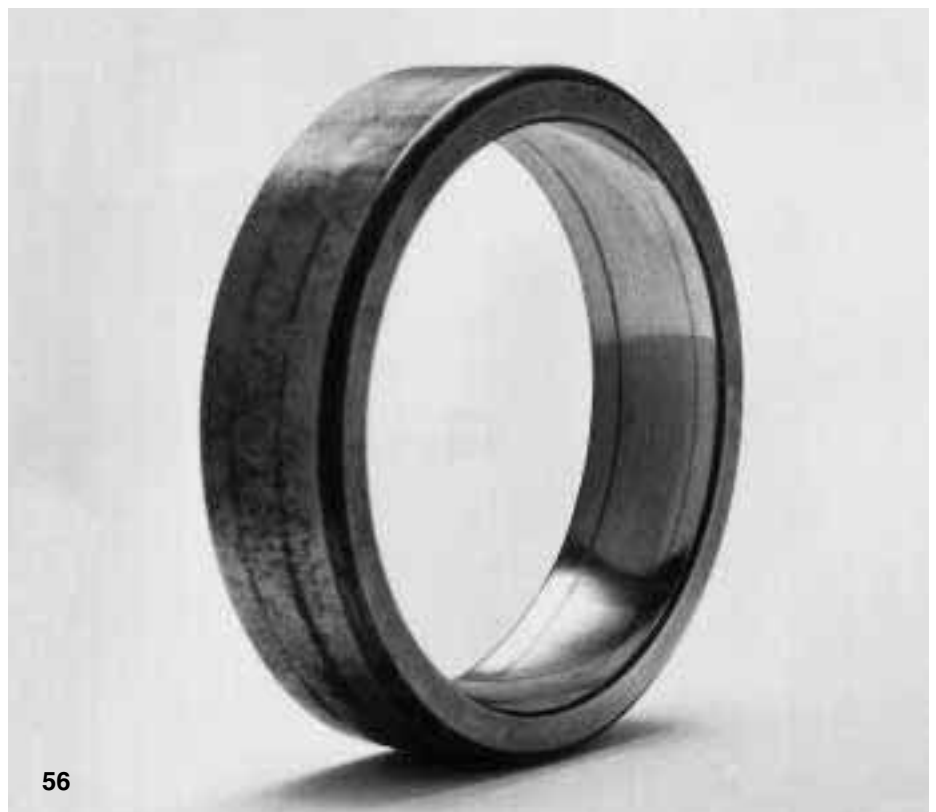
Fig 56 Outer ring of a self-aligning ball bearing that has been driven too far up its tapered seating. The bearing had only performed a few revolutions when the damage was detected. Flaking would soon have occurred if the bearing had been put into service

| Appearance | Cause | Action |
|--|---|---|
| | Temperature differential between inner and outer rings too great. | Select bearing with larger internal clearance. |

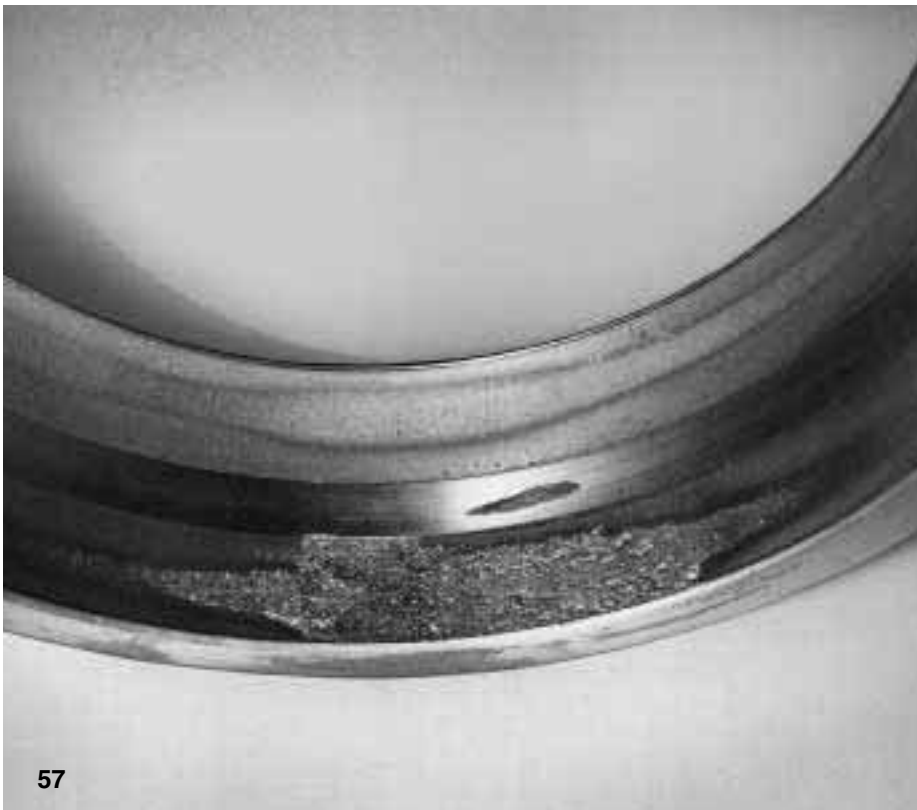
Fig 57 Flaking in the outer ring outer ring of spherical roller bearing that has been mounted in a housing with oval bore

Adjust the base.

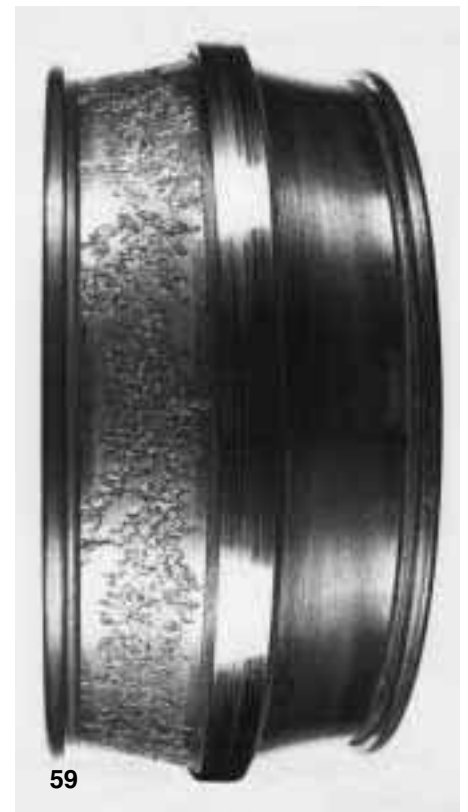
Fig 58 Outer ring of a self-aligning ball bearing subjected to excessive axial loading. Flaking in the load zone

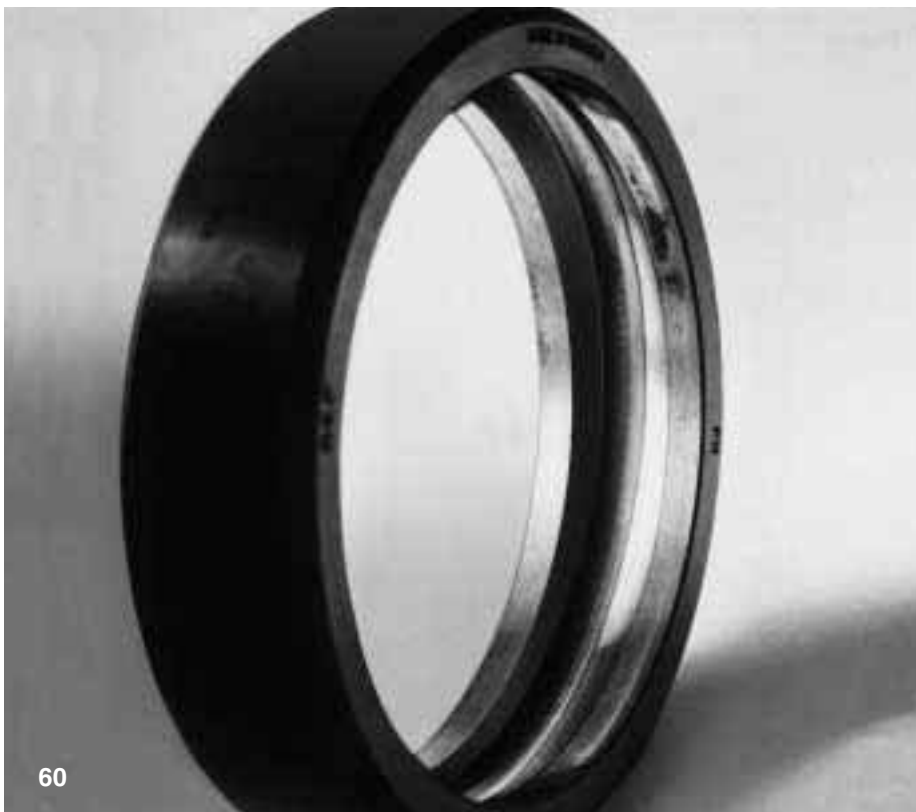
Fig 60 Deep groove ball bearing outer ring that has been out of alignment with the shaft. The ball path has an oval configuration on account of the misalignment. The result is the same as with oval compression, see page 31

Rectify the seatings.
Use mounting sleeve with parallel faces.

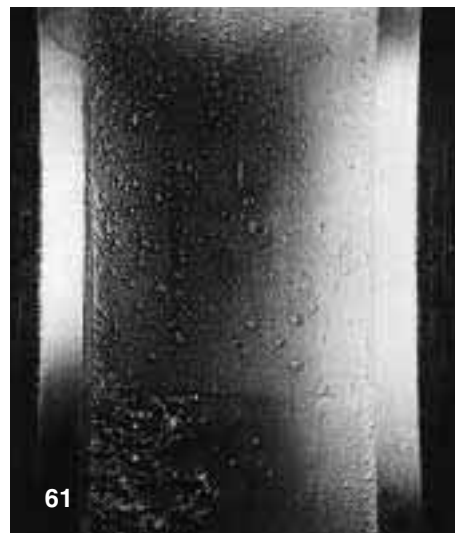
Fig 61 Cylindrical roller bearing inner ring with flaking at one side of the raceway, as a result of overloading due to misalignment

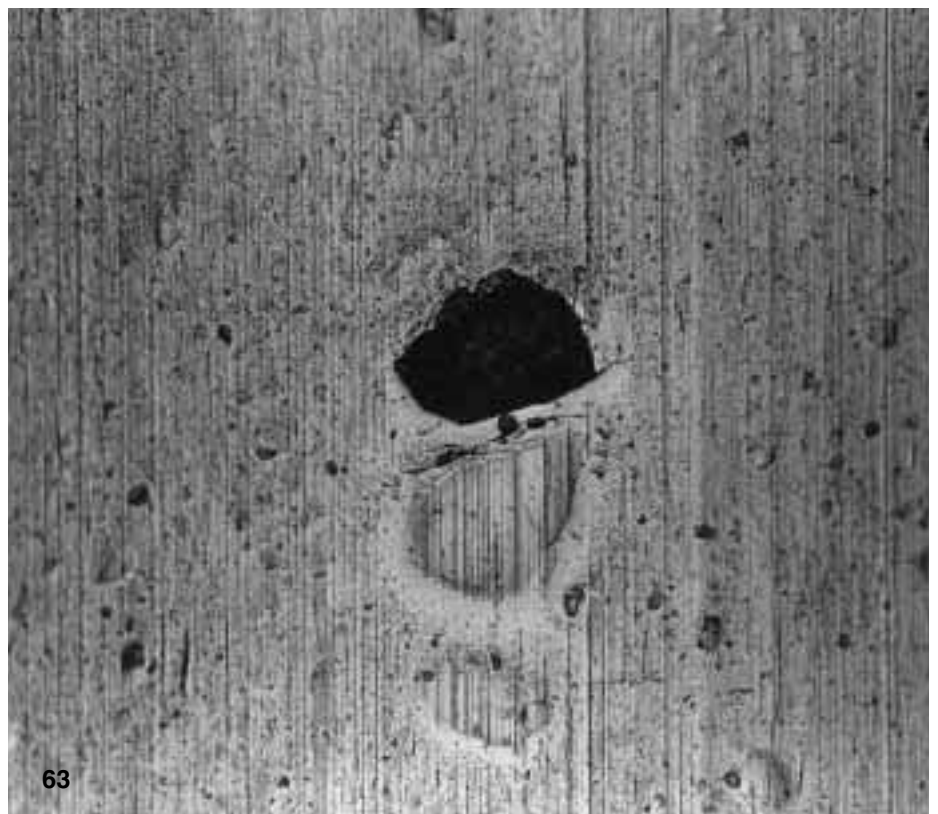
Fig 62 Various stages of flaking in the inner ring of a deep groove ball bearing. The ring has been mounted with interference fit on the shaft and blows have been directed against the outer ring, causing the mounting force to pass through the balls, which have produced the indentations

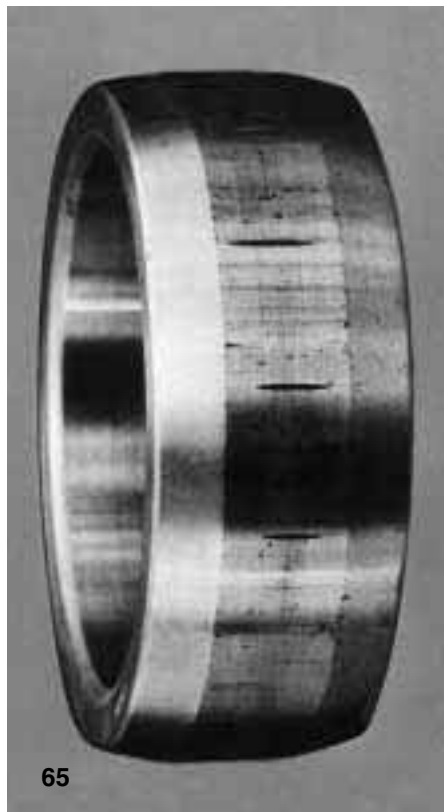
Fig 64 Inner ring of a cylindrical roller bearing with extensive flaking caused by smearing of the kind depicted in fig 65

Transverse smearing resulting from faulty mounting practice, see page 19.

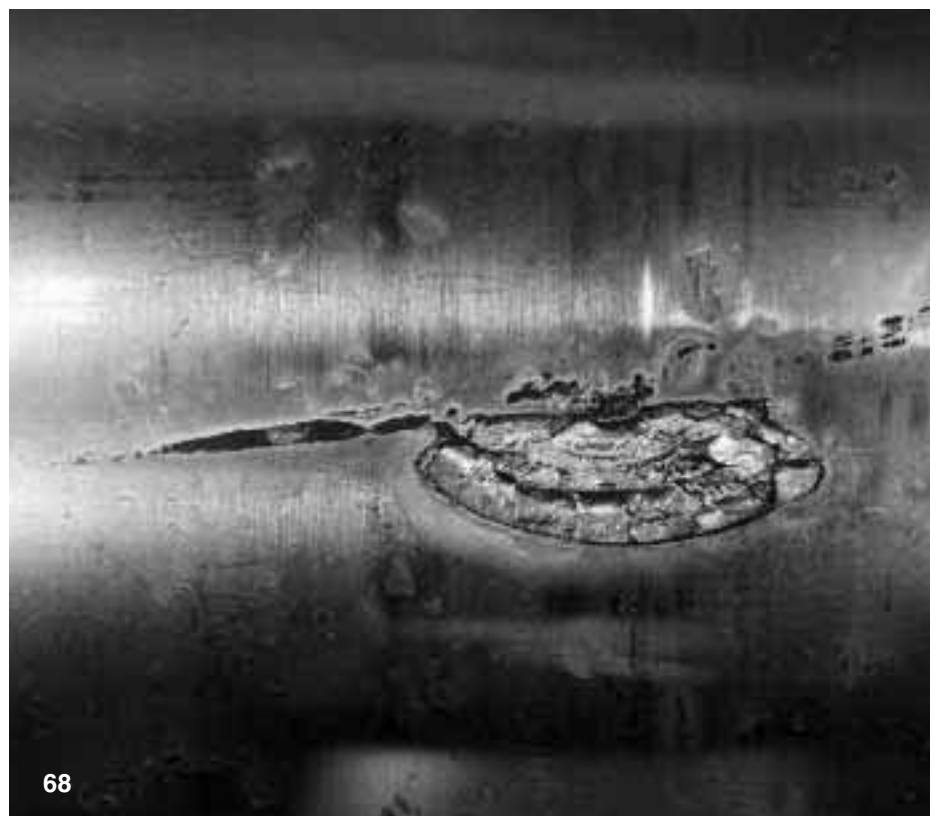
Fig 67 Cross section through the roller depicted in fig 66, showing the way in which the fatigue crack extends beneath the surface. The fully developed flaking originated in the same manner

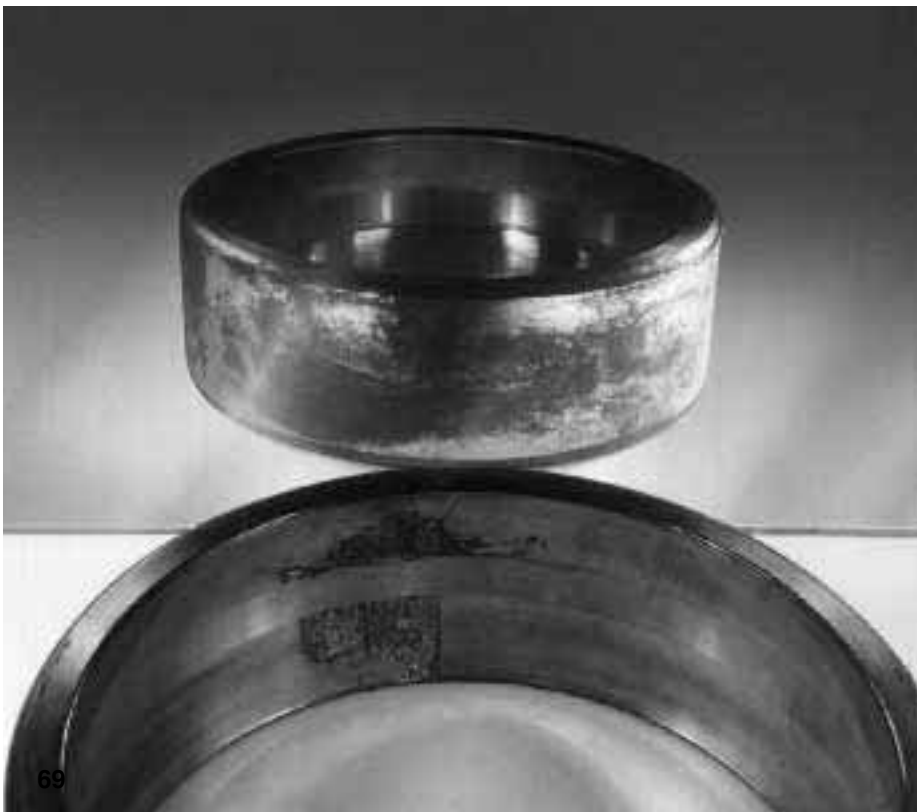
Fig 69 Flaking in the raceways of the outer ring of a spherical roller bearing. Corresponding area of advanced fretting corrosion on the outside surface (for this photograph the ring has been placed in front of a mirror). Development of the corrosion has been accompanied by an increase in volume that has led to deformation of the bearing ring and localised overloading. The results have been premature fatigue and flaking

Fretting corrosion, see page 25.

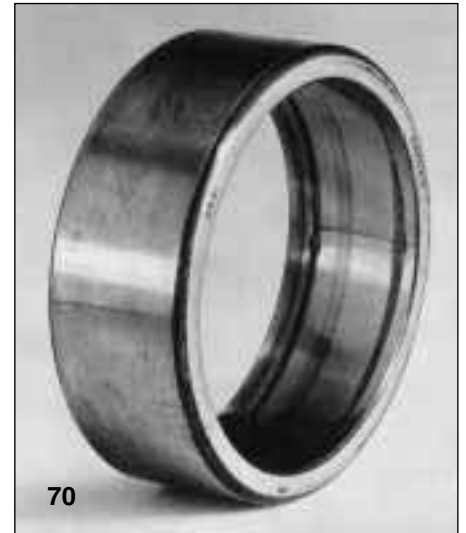
Fig 70 The outer ring of a self-aligning ball bearing with flaking caused by craters that have formed in conjunction with the passage of electric current. It is evident that the flaking has originated at the craters, from where it has spread out in both directions. Detached fragments of flaked material have in turn caused indentations and further flaking

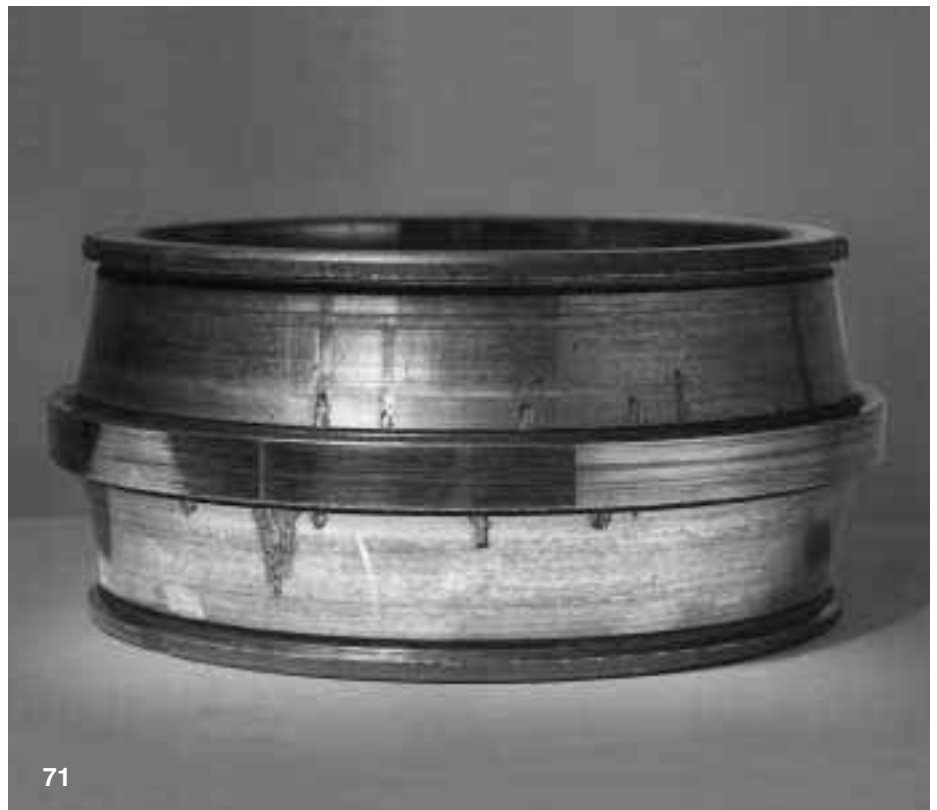
Fig 71 Flaking in both raceways of the inner ring of a spherical roller bearing. The flaking has originated from the vibration markings

Electric current damage, see page 26.

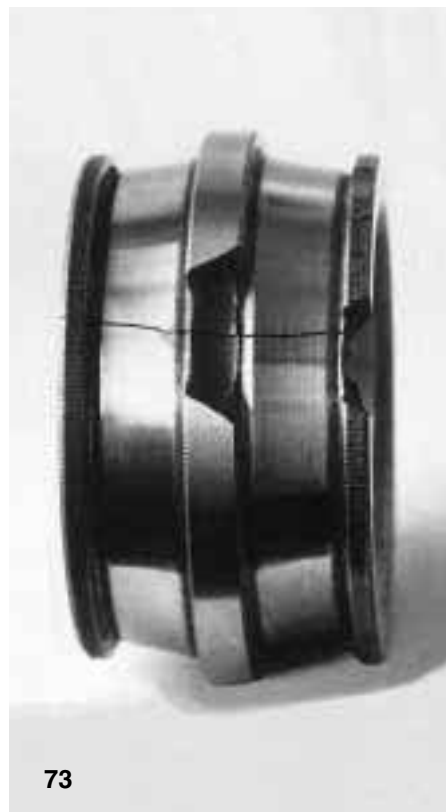
Fig 73 Cracked inner ring of a spherical roller bearing. One roller has been removed to allow the raceway of the left-hand of the photograph to be examined. The roller has then been hammered back in place, causing part of the centre flange to break away. The impacts have been transmitted via a roller in the other row and part of the outer flange has broken off too. At the same time the ring has cracked right through

Always use a soft drift or mounting sleeve. Never subject the bearing to direct hits.

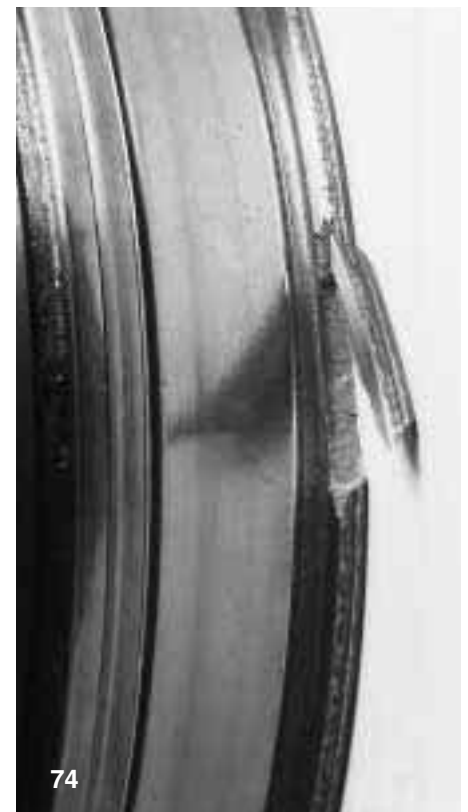
Fig 74 Inner ring of a spherical roller bearing with outer flange fracture produced by direct hammering

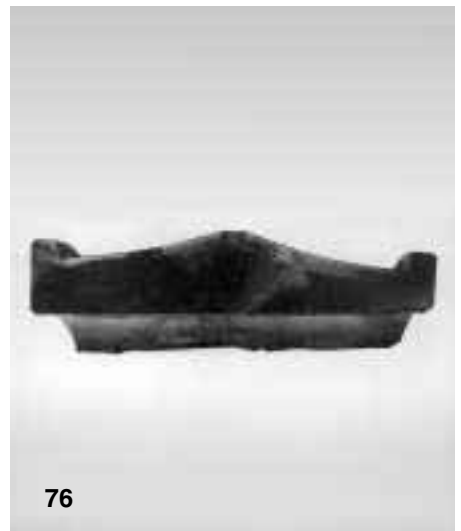
Fig 76 Fractured surface of the inner ring in fig 75
